DTAC 0006
LAYOUT DIAGRAM
TACTILE GROUND SURFACE INDICATORS (TGSI)-WARNING
VERSION 03
PUBLISHED 28.10.11

Installation Notes:
TGSI Warning Indicators installed on a stair with adjacent ramp and continuous handrails

Mulgrave Country Club

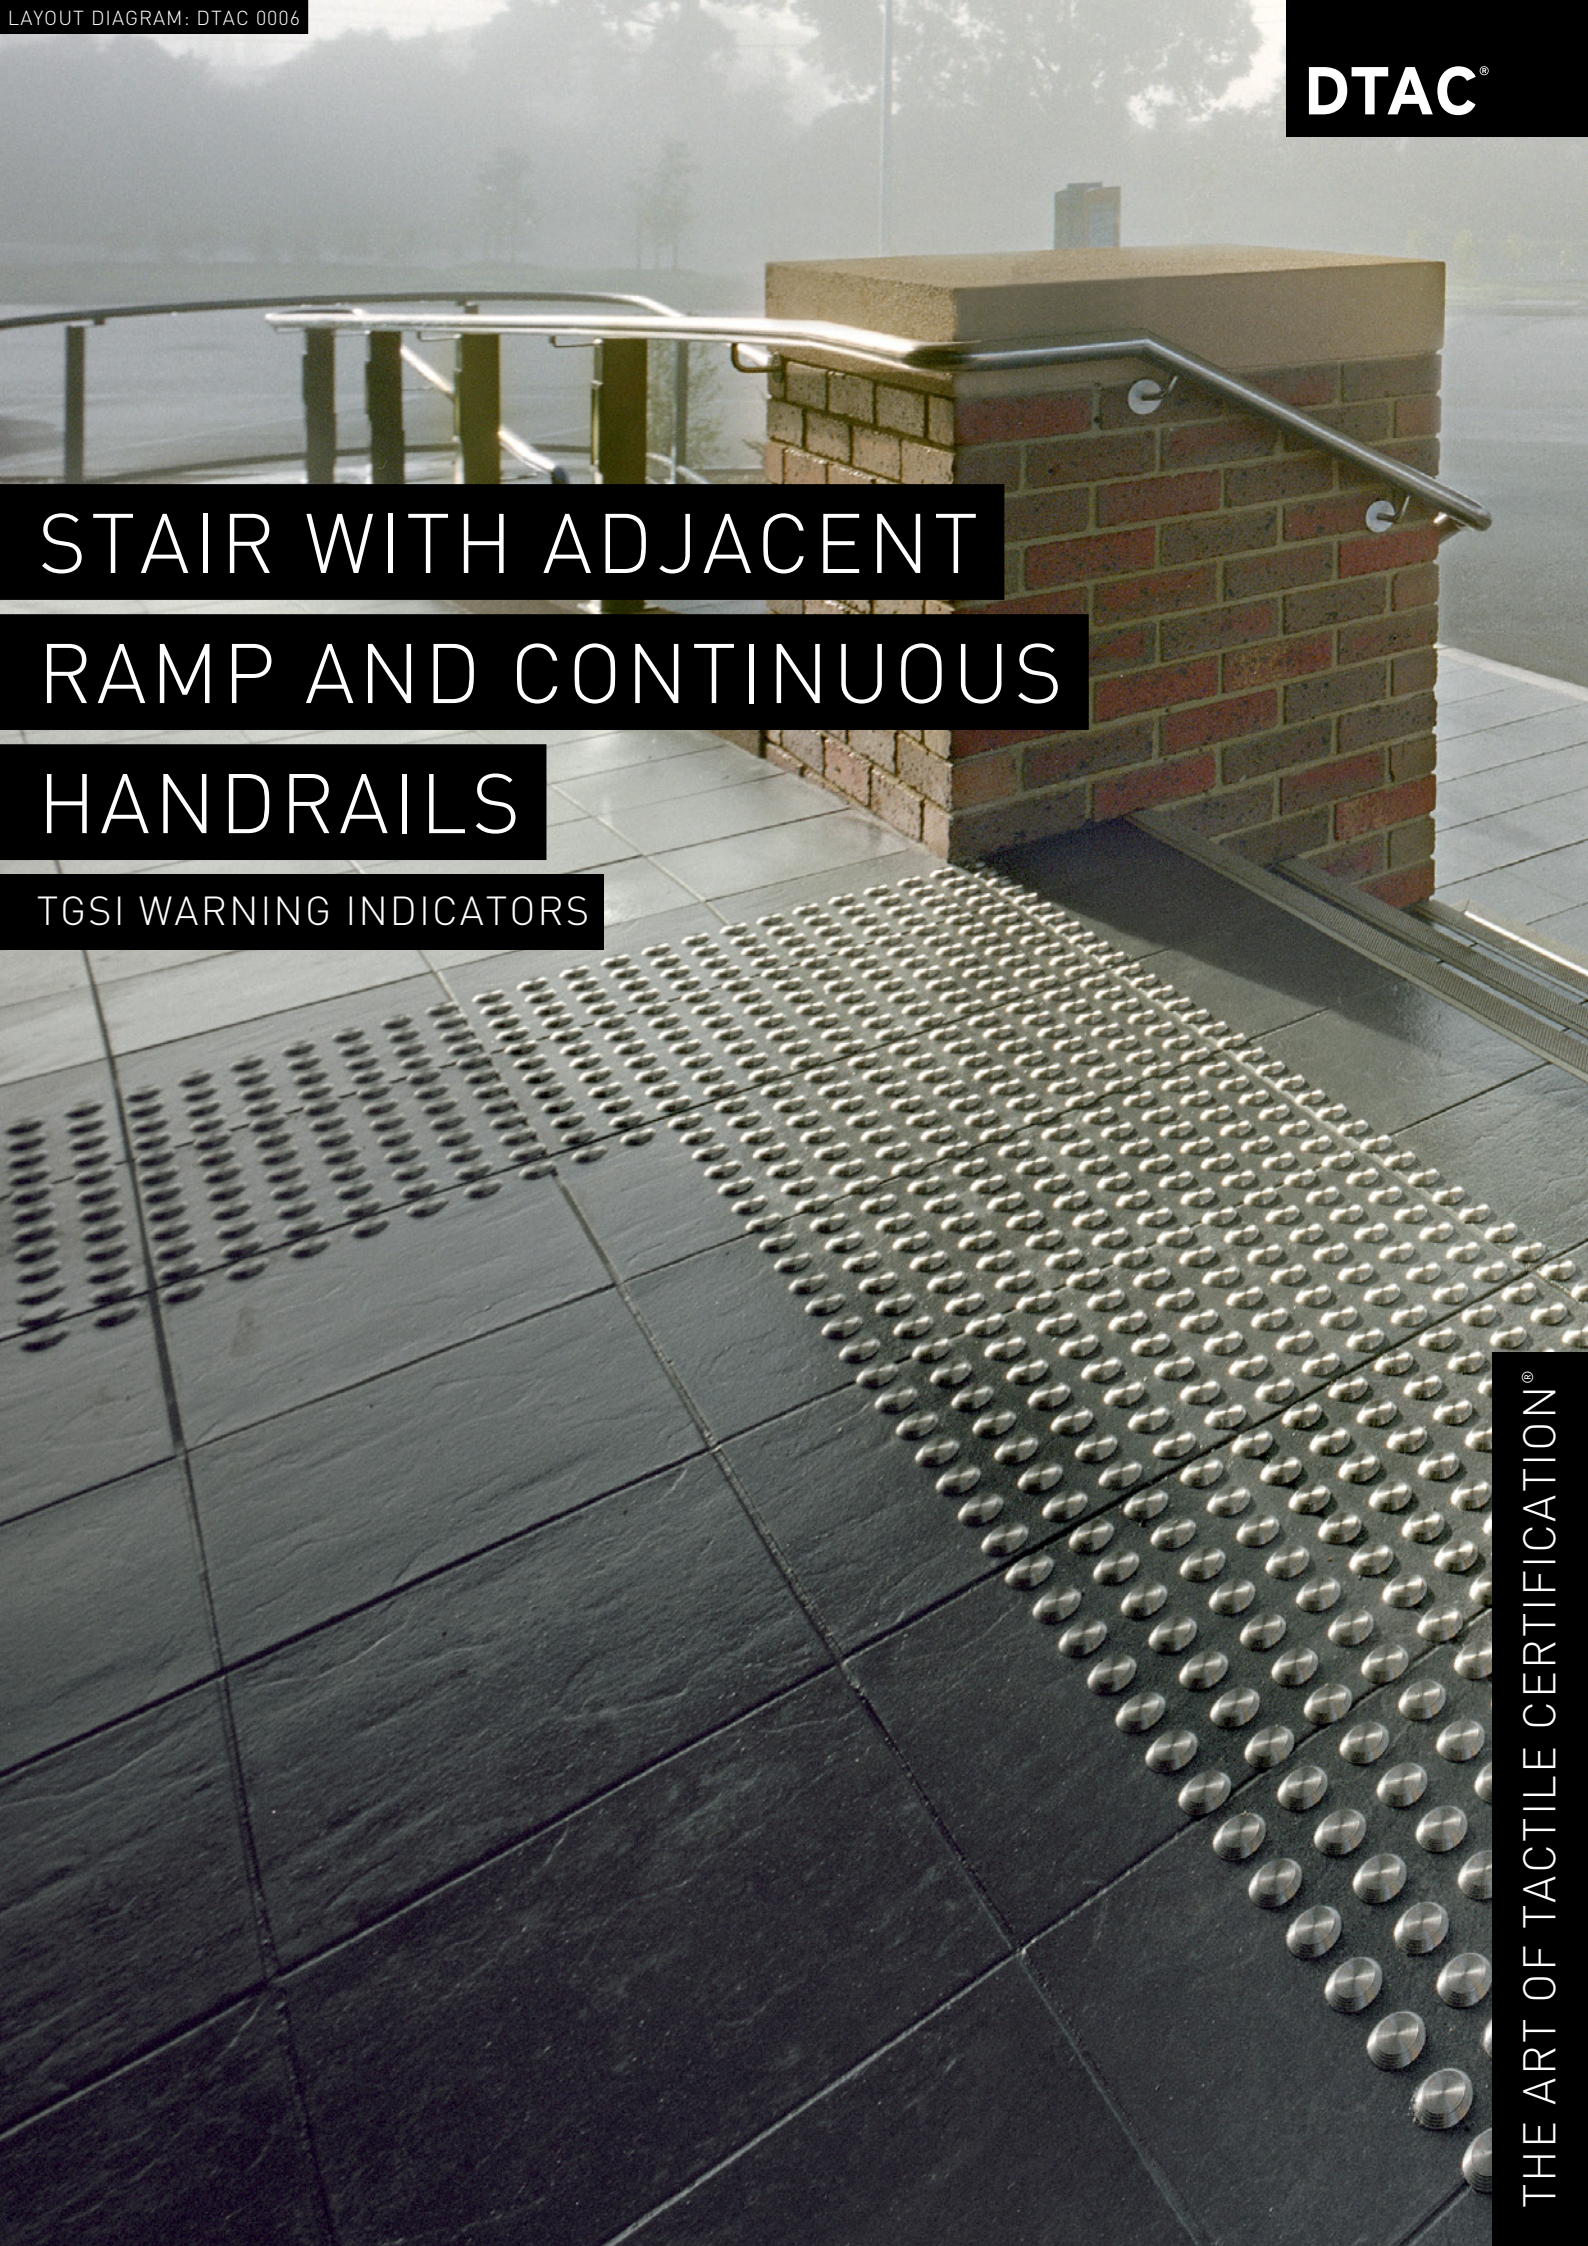
This project required a standard application of Warning TGSI's to the top and bottom of the paths of travel between two levels of this entry. Two TGSI areas of 600mm by the width in between the path of travel (in this case in between the handrails) were employed to give a clear tactile cue for both the approach and the alighting from the stair and ramp. For further detail and information see AS/NZS 1428.4 (2002).

Layout of discrete warning TGSI's
Drawings in millimetres
Drawings not to scale unless noted
