EXTERNAL BUILDING ENTRY

WITH ACCESS RAMPS

INTERSECTING CENTRAL STAIR

DTAC 0026  
LAYOUT DIAGRAM  
TACTILE GROUND  
SURFACE INDICATORS  
(TGSIs)-WARNING  
VERSION 02  
PUBLISHED 27.05.1

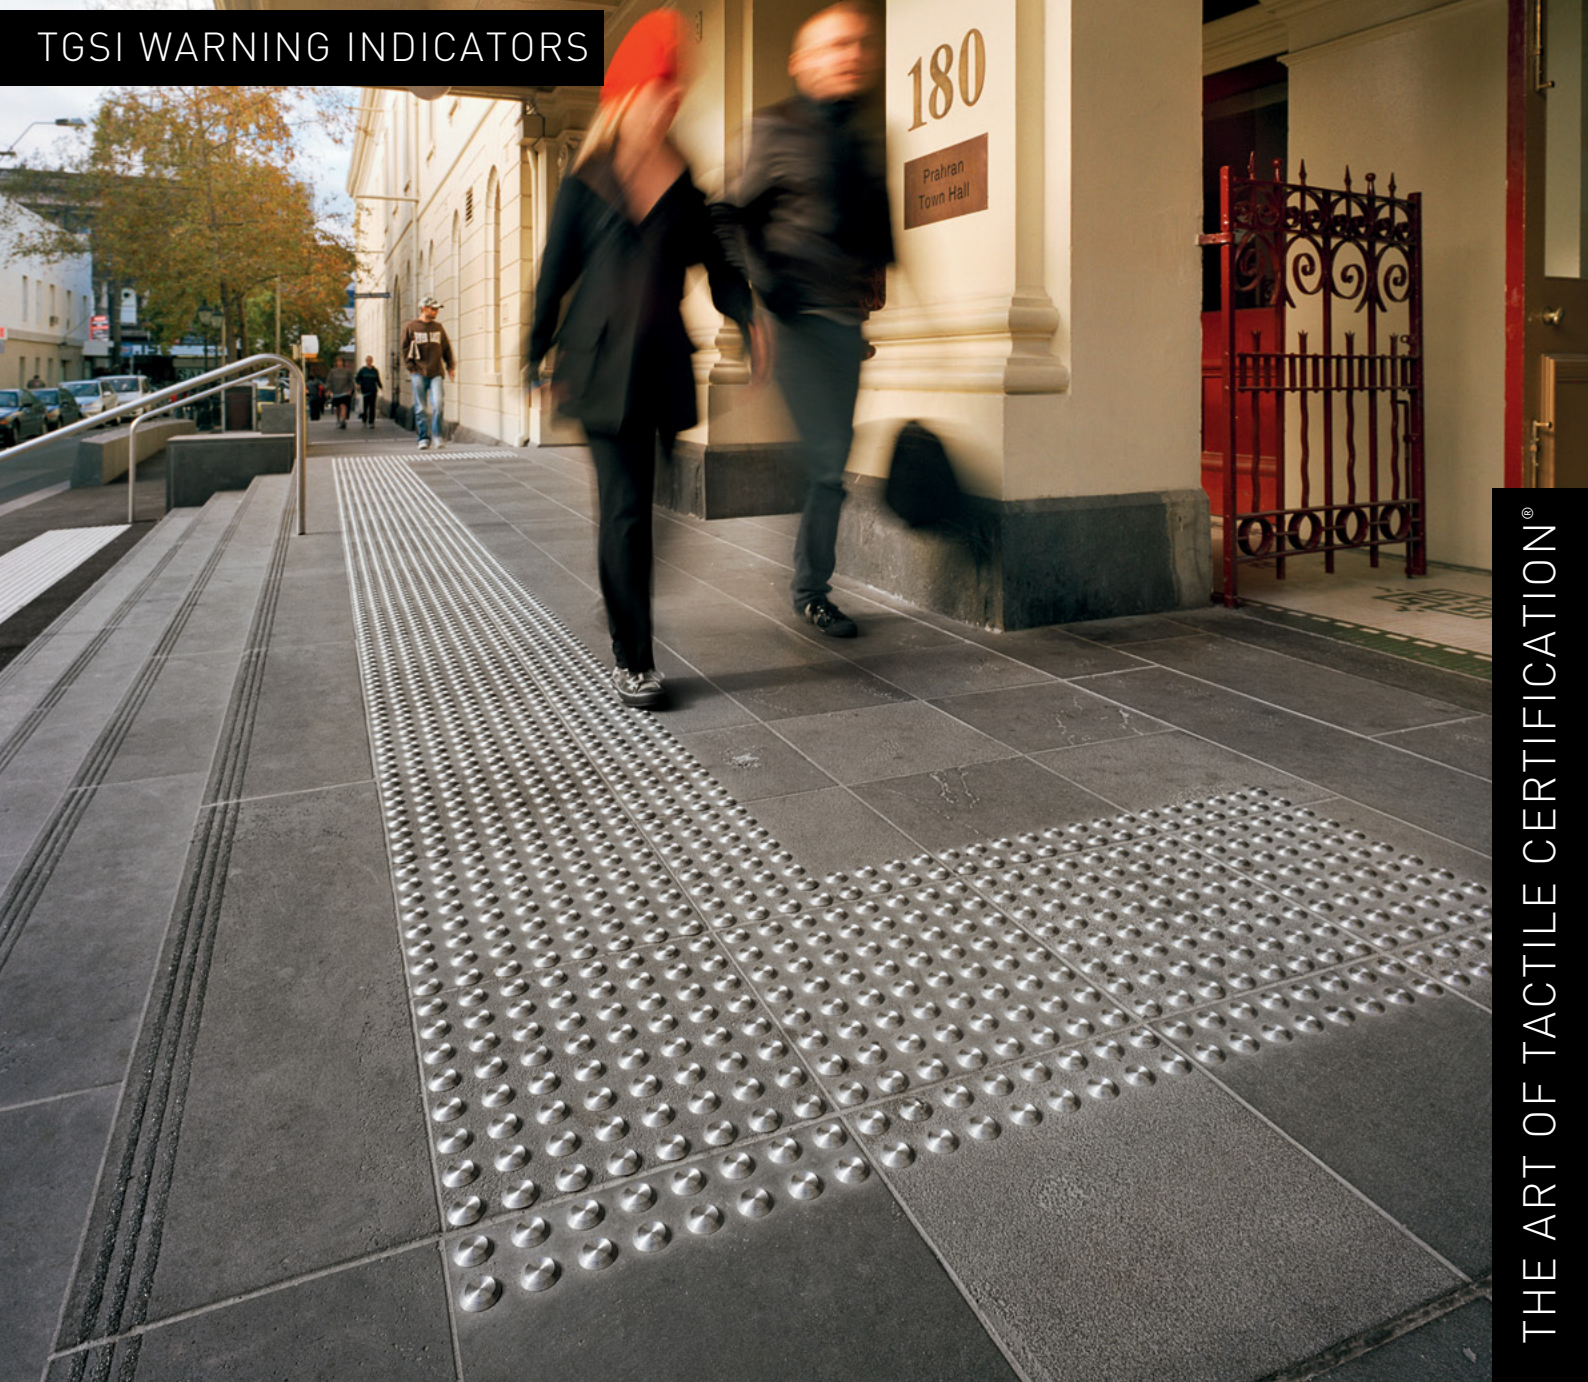
Installation Notes:  
TGSi Warning Indicators installed at  
building entry with access ramps  
intersecting central stair.

Originally this heritage listed building had stairs to the left and right sides of the central staircase. To improve access, ramps were designed and installed to look as they are depicted. As a result TGSi's were retrofitted on existing pavements. As there are several directions of travel that can be chosen when alighting from the building, TGSi's have been used around the entire hazard to give a constant message to the user providing safe and guided access.
