ACCESSIBLE PATH  
WITH ADJACENT SUNKEN  
GARDEN BED

TGSI WARNING INDICATORS

DTAC 0037  
LAYOUT DIAGRAM  
TACTILE GROUND  
SURFACE INDICATORS  
(TGSIs)-WARNING  
VERSION 02  
PUBLISHED 27.05.1

#### Queensland Art Gallery— Gallery of Modern Art

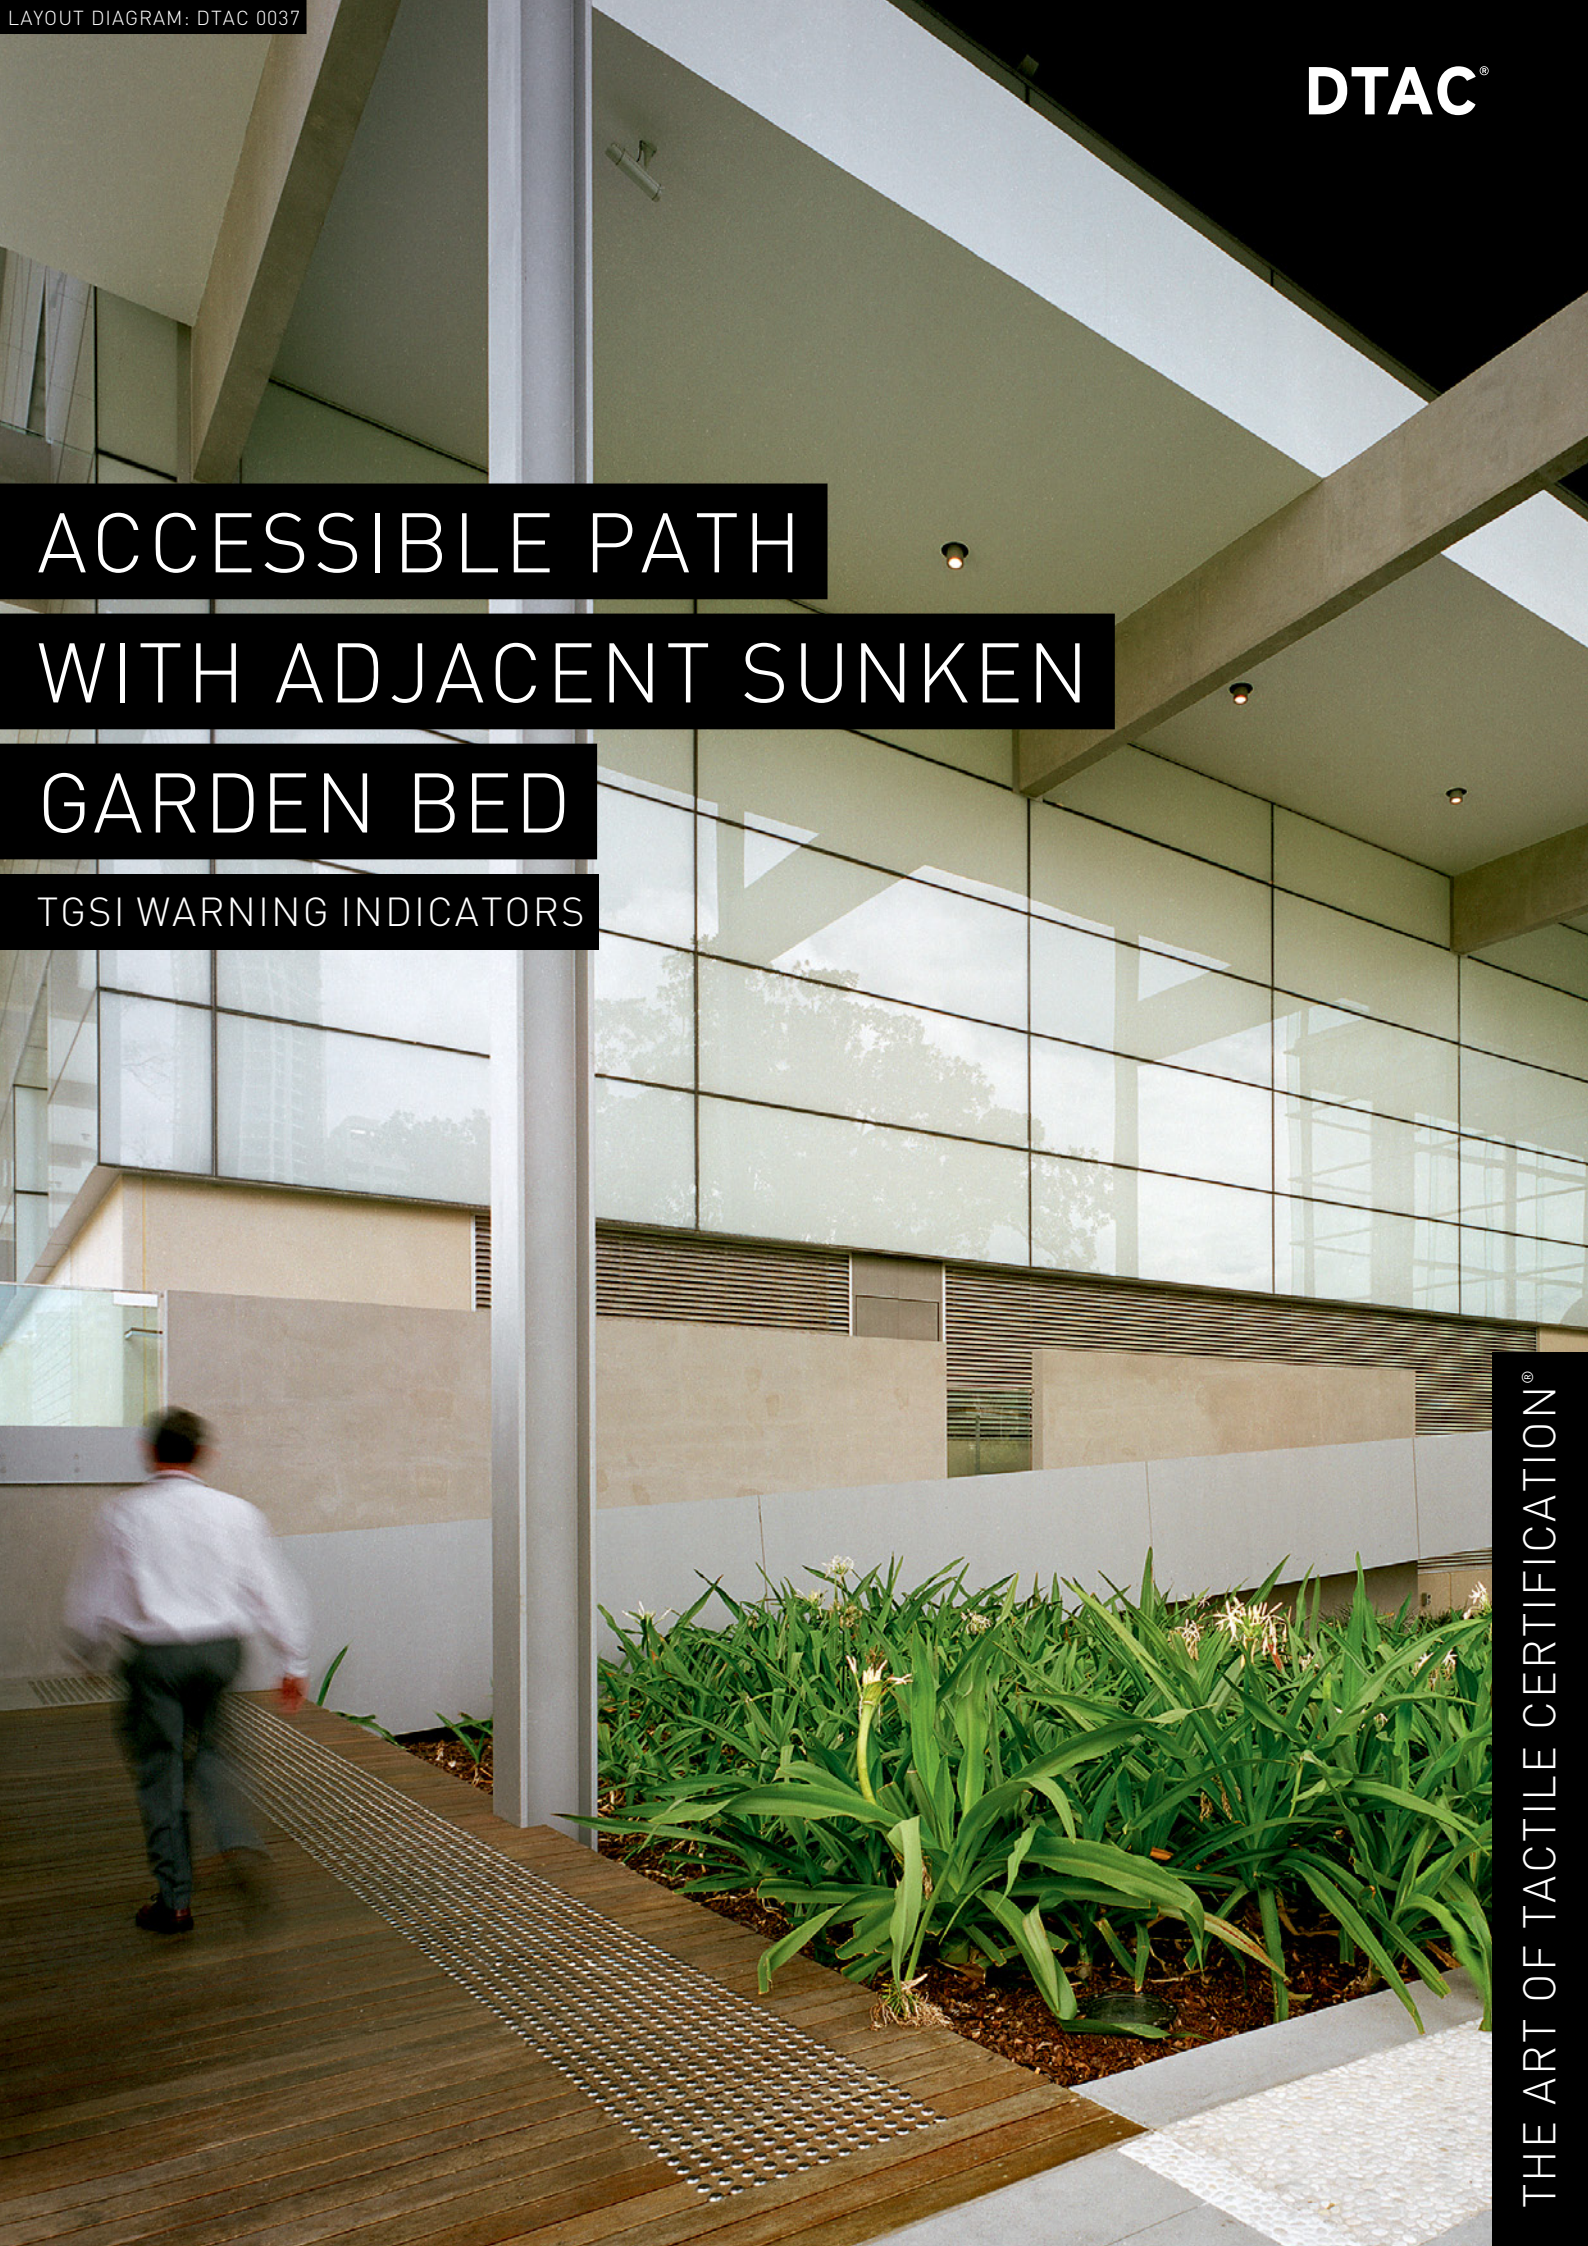
FIGURE 0037-A

In many situations TGSi's can be used to alert the visually impaired to hazards they may encounter in situations that may not be a 'stock-standard' application.

This application of TGSi's depicts a unique situation where a main accessible route into a building has an adjacent sunken garden bed that the pedestrian is not protected from as a potential hazard. TGSi's have subsequently been installed (a 600mm deep pad) to alert the visually impaired, set 300mm back from the sunken garden bed along the full width of the hazard.

If natural 'Tactile Cues' were available, (e.g. walls, handrails or even raised garden beds), TGSi's would have not been required.

Layout of discrete warning TGSi's  
Drawings in millimetres  
Drawings not to scale unless noted
