ENTRY RAMP THROUGH A DOUBLE DOORWAY

TGSI WARNING INDICATORS

DTAC 0021
LAYOUT DIAGRAM
TACTILE GROUND
SURFACE INDICATORS
(TGSIs)-WARNING
VERSION 02
PUBLISHED 27.05.1

Gucci Store

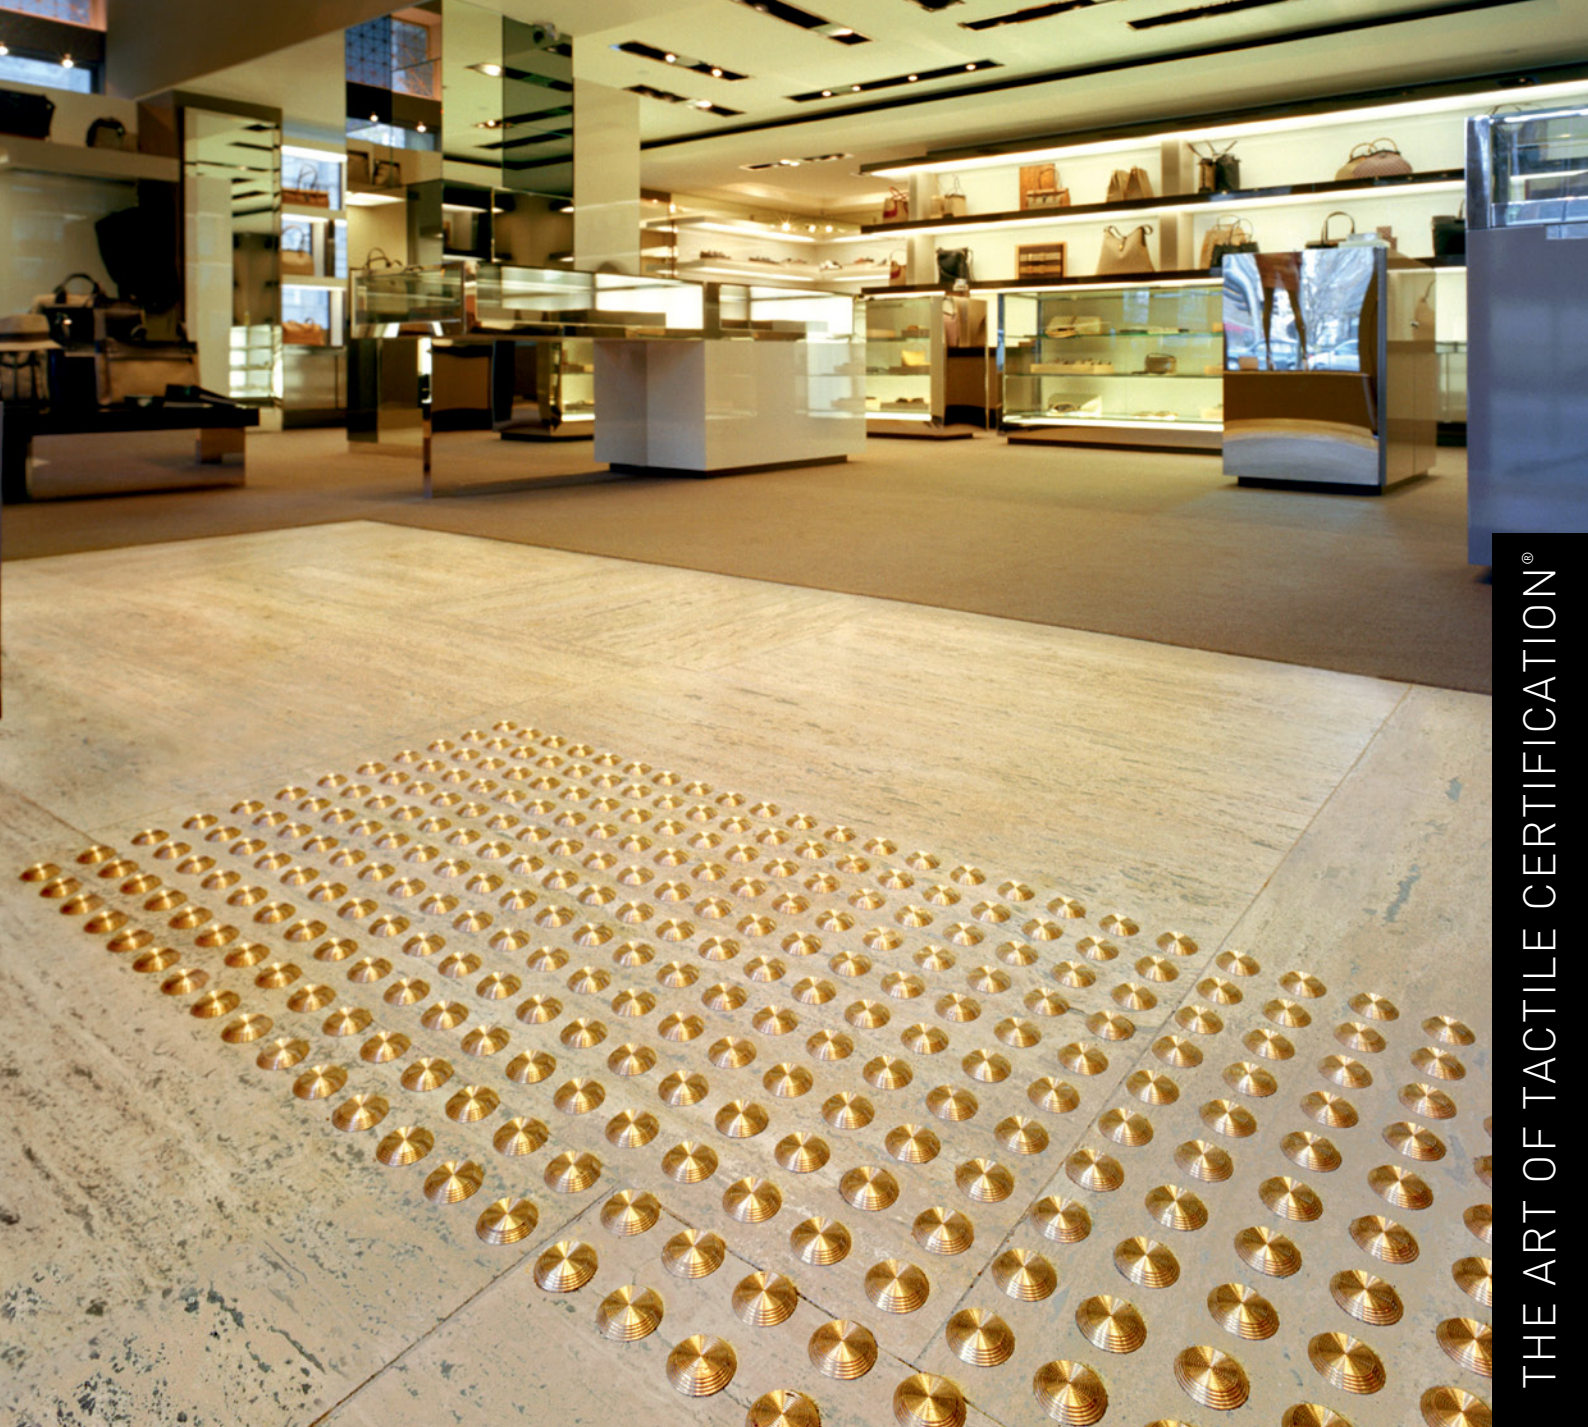
Installation Notes:
TGSi Warning Indicators installed on a entry ramp through a double doorway.

When renovating existing buildings many regulatory bodies request the architecture be upgraded to current building regulations and codes as was the case for the Gucci store. TGSi's were installed across the full width at the top of the entry ramp inside the building. However, the TGSi's were not installed on the base of the entry ramp as the application fell onto the jurisdiction of the local municipal body and was deemed to be the responsibility of building owner.

The result, whilst visually effective internally, gives the visually impaired a mixed message and doesn't meet requirements of AS/NZS 1428.4 or the Disability Discrimination Act. TGSi's assist the visually impaired alerting them to where they are, where they are going and have been. Only half the message is being given in this situation and you need to be inside the building to use the TGSi's. Working with a professional and accredited access consultant would have provided the end client with a more accessible and practical design and the need for TGSi's could have been removed completely.
