STANDARD ESCALATOR/ TRAVELATOR

TGSI WARNING INDICATORS

DTAC 0008
LAYOUT DIAGRAM
TACTILE GROUND
SURFACE INDICATORS
(TGSIs) - WARNING
VERSION 03
PUBLISHED 28.10.11

**NGV International,
National Gallery of Victoria**

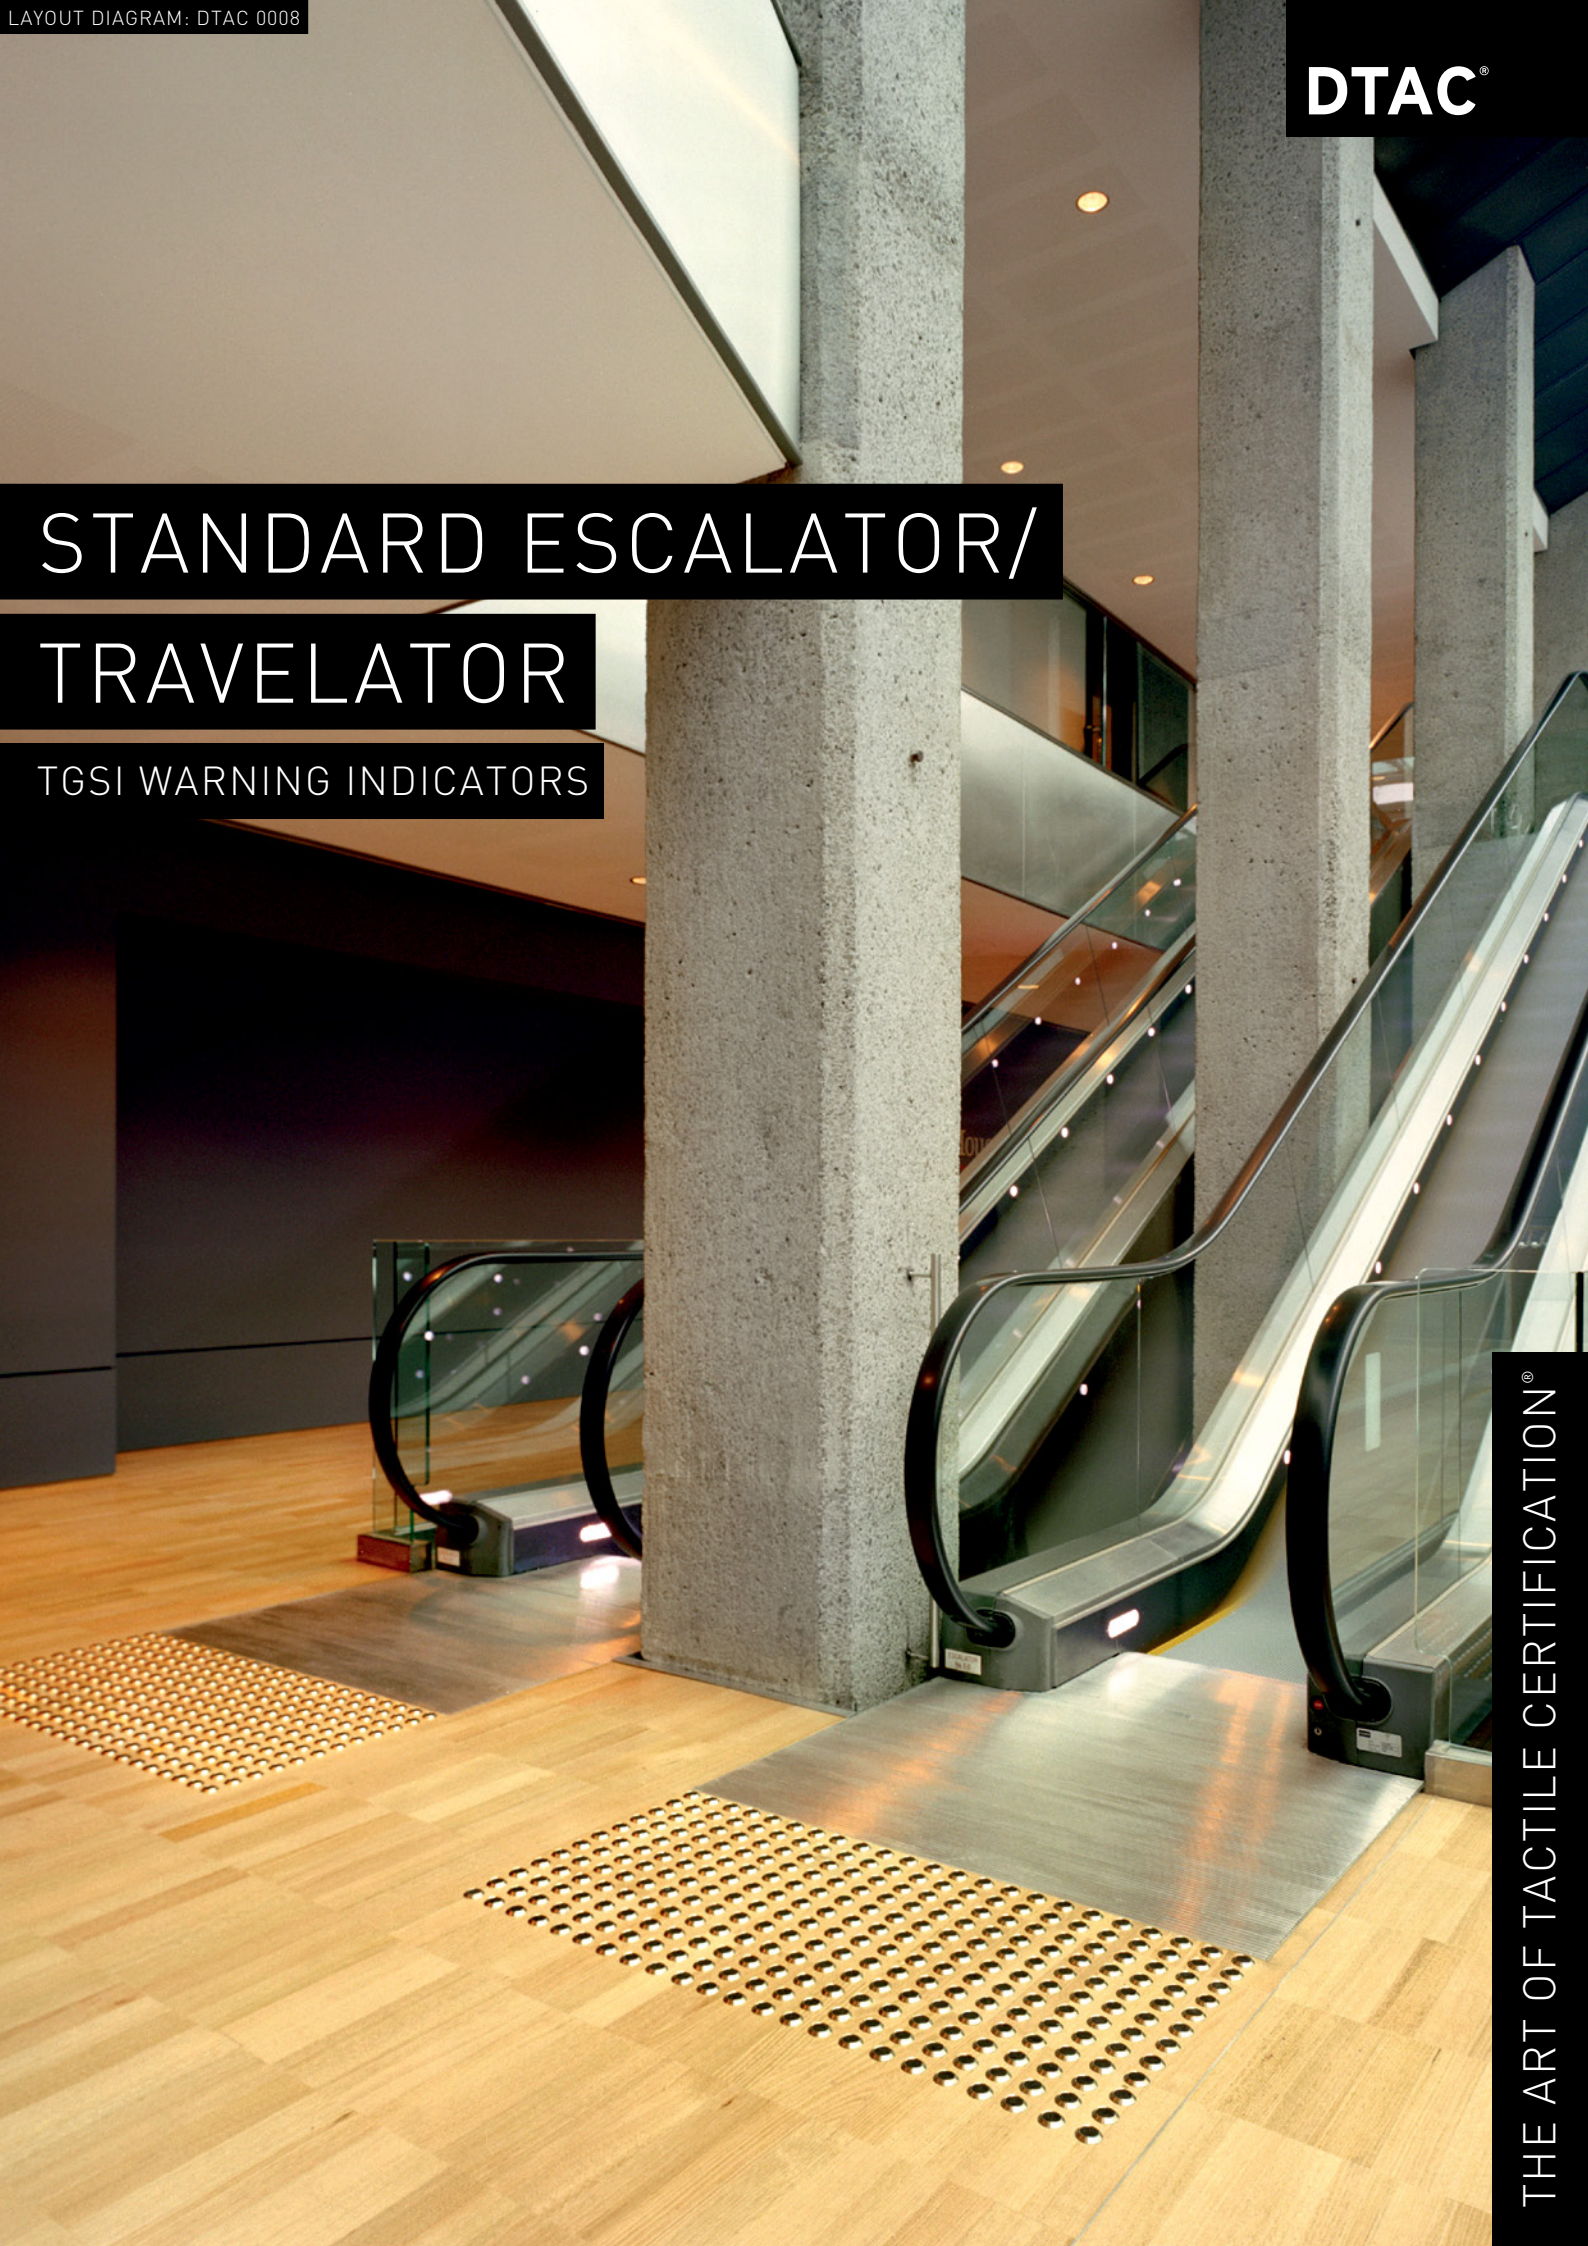
FIGURE 0008-A

Installation Notes:
TGSi Warning Indicators installed
on a standard escalator/travelator.

This project required a standard application of warning indicators to the top and bottom of the escalators. Warning Indicators set 300mm back from the edge of the moving handrail to a depth of 600mm by the width between of the moving stairway, (in this case, between the centre of the moving handrail to the other), were installed to give a clear tactile cue for both the approach and alighting from the moving stairway. For more detail, see AS/NZS 1428.4 [2002].

Layout of discrete warning TGSi's
Drawings in millimetres
Drawings not to scale unless noted
